Demonstration of Corrosion-Resistant Fire Hydrant Retrofits For Military Installations

Final Report on Project F09-AR12

October 2013

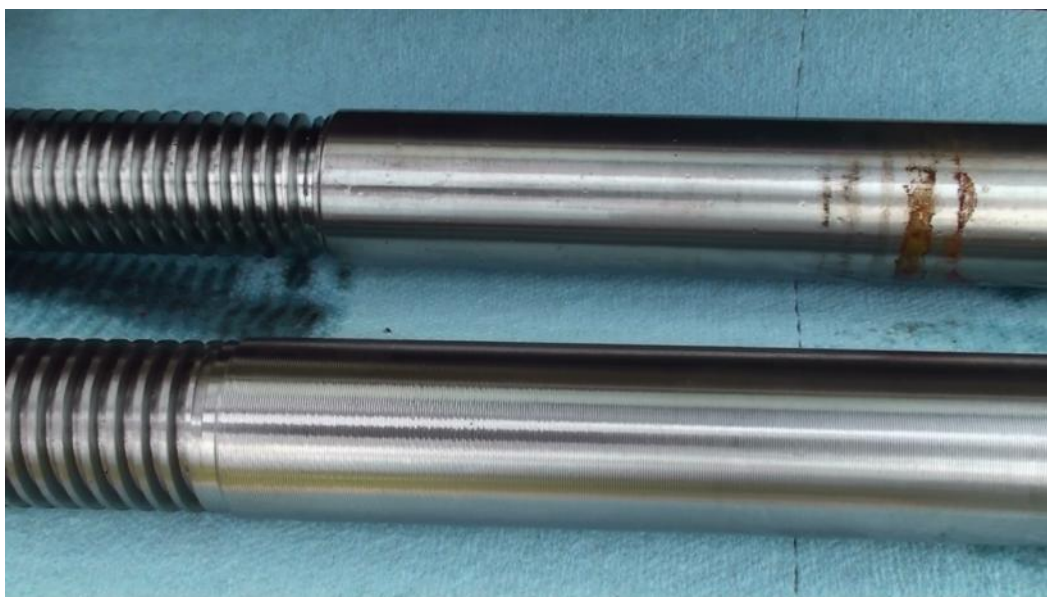
After 12 months of exposure, none of the inspected stainless steel stems showed any signs of corrosion. Ferrous oxide residue from the lower stem and the bonnet had discolored the stainless steel stem in two places (Figure 18). The cold-rolled stem was severely corroded at the bottom of

Figure 18. DATV 304 stainless steel stem designed by DATV for a Mueller Standard hydrant after 12 months of exposure (top) and no exposure (bottom).

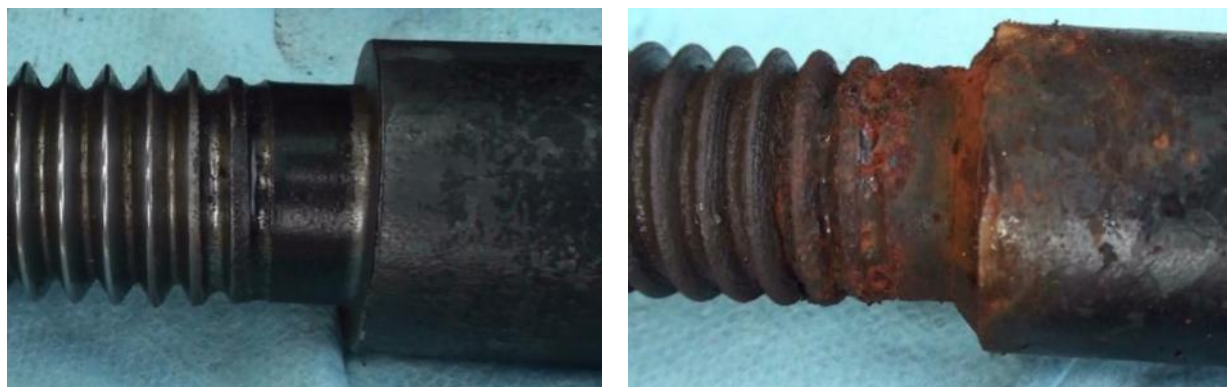
the threaded area and the bottom of the stem (Figure 19). The top of the threaded area was protected inside the oil reservoir. The remainder of the stem is protected by the phosphate coating from the manufacturer, but the coating has begun to fail at the thread transition to the solid surface. As a result, lateral undercutting corrosion and blistering has caused the loss of adhesion between the paint and the metal substrate. Further corrosion of the cold rolled stem is expected over time.

Figure 19. Cold-rolled stem design as supplied by manufacturer (Mueller Standard) with zero days of use (left) and 12 months exposure (right).

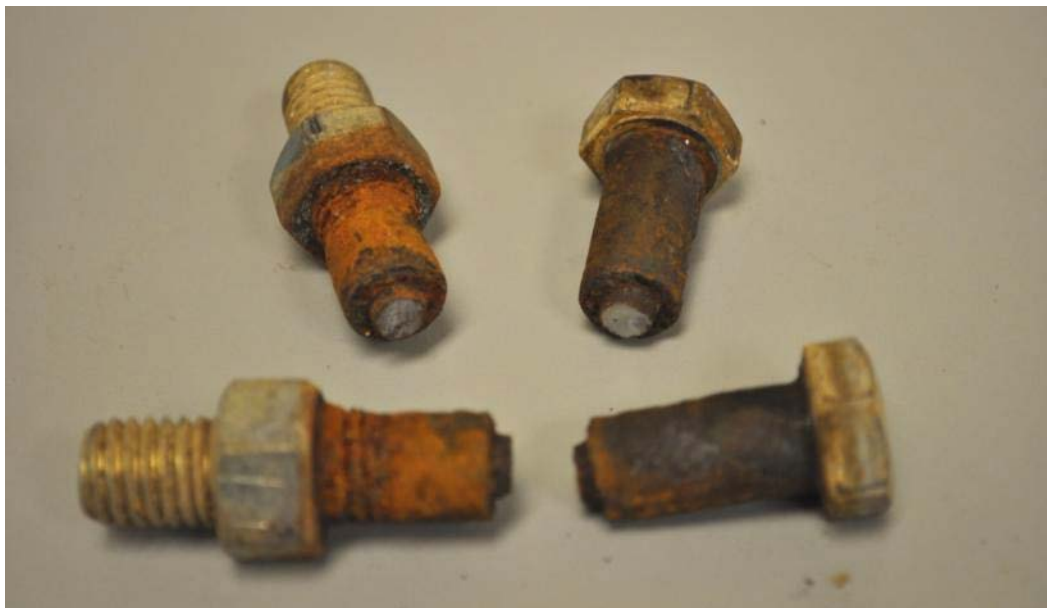
Most of the inspected DATV parts were in excellent condition after 12 months of use. However, severe corrosion was found on many bolts that hold the upper barrel to the lower barrel. Such corrosion is normal with the breakaway bolts supplied by a hydrant's manufacturer and is unrelated

to the DATV kit. Figure 20 shows two examples of corrosion on breakaway bolts that were removed from service after 12 months of operation.

Figure 20. Corrosion on breakaway bolts 12 months after installation.

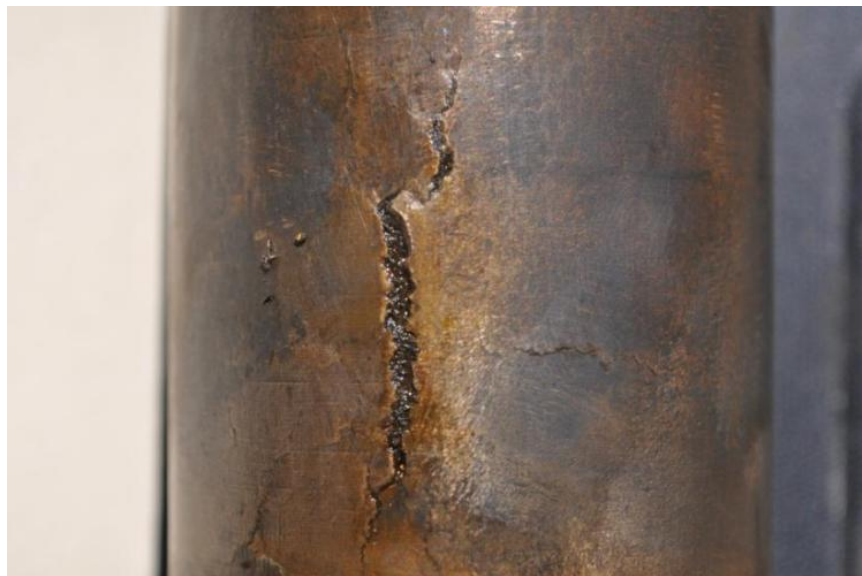
During installation of the DATV kits, several hydrants were found with standing water in the barrel. This was caused by clogging of the weep/drain holes included in the lower barrel of the original hydrant. The weep holes allow water to drain from the barrel after the hydrant is closed.

Water trapped in a barrel can freeze and damage hydrant components. Figure 23 and Figure 24 show cracking and bulging of a brass operating nut caused by water freezing (see Appendix D for analysis). This kind of damage can interfere with hydrant operation. The barrel sleeve included in the DATV kits has a check valve to allow water to drain from the upper barrel, but if the weep holes are clogged, the barrel will not drain.

Figure 23. Operating nut sleeve* showing cracks due to freezing water trapped inside the barrel.

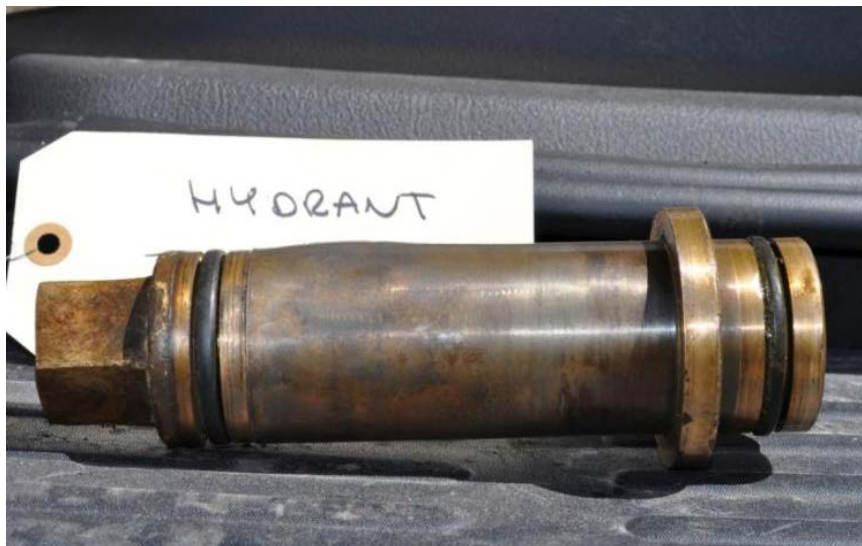
Figure 24. Bulge in operating nut sleeve.

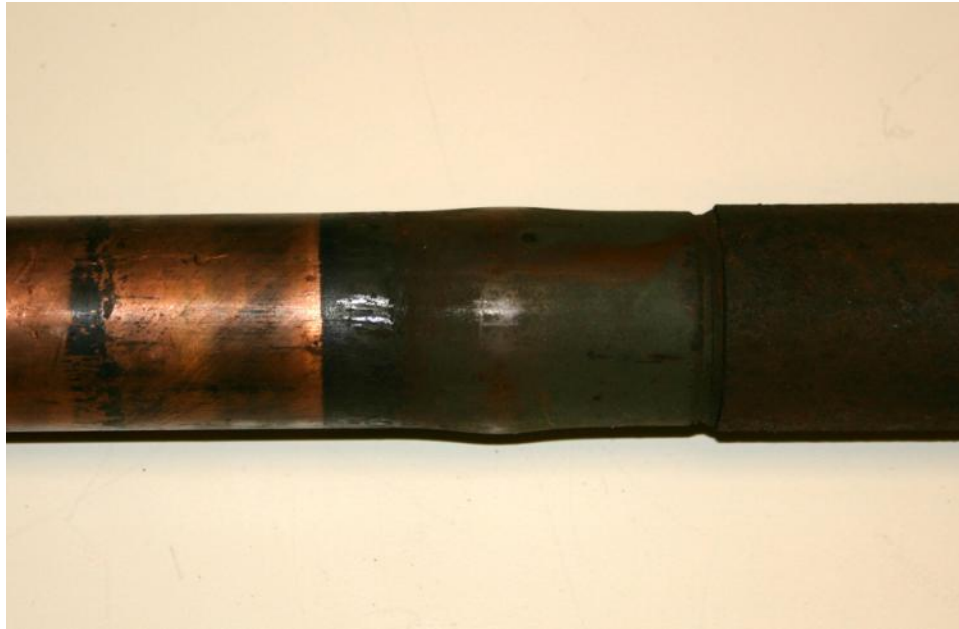
ilar metals caused localized corrosion in the affected area. The increase in volume of the corrosion product caused the copper sleeve to bulge in places where corrosion products accumulated on the steel shaft. In order to stop this type of corrosion in a valve stem of this design, the assembly must be sealed against intrusion of moisture between the copper sleeve and steel stem. If freezing contributed to the bulge, the solution to that problem also would require keeping moisture out of the affected area.

Figure D1. Fire hydrant valve stem showing bulge in copper sleeve.
